**TEXT** Dipl.-Ing. Thorsten Pasz, Brauer Maschinentechnik AG, Bocholt/Germany

## BRAUER MASCHINENTECHNIK AG

# Repair of two cement mill gear units at a Belgian cement plant

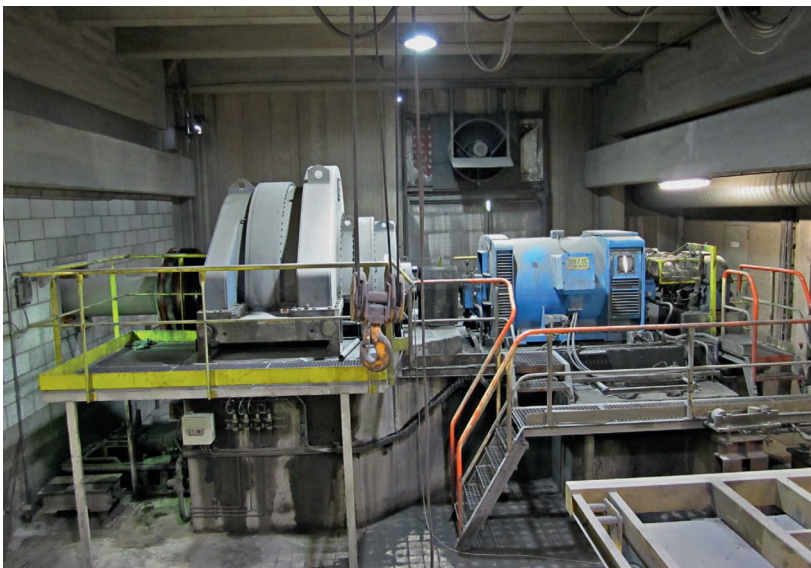
A cement plant in Antoing, Belgium, has a pair of horizontal ball mills with two-stage planetary

gear units (Fig. 1) that have been in service for about 50 years. Some time ago, one of the machine's smaller stages was repaired, and a subsequent video endoscopic inspection performed by Brauer Maschinentechnik AG revealed some damaged teeth and cracks in the casing.

1 Gear unit in installed state prior to overhaul

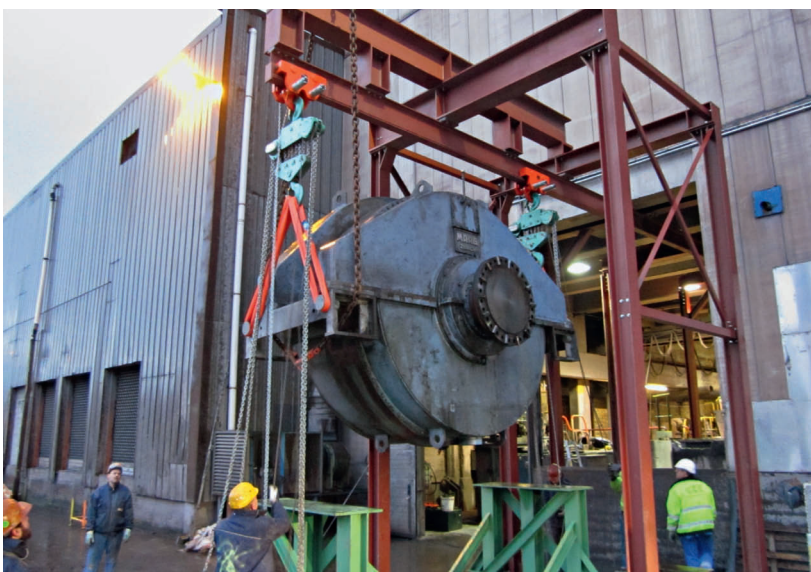
2 Big (38-ton), freshly extracted planetary stage

After the heavy curved-tooth couplings to the cement mill were separated and secured came the much more difficult part: disassembly of the big planetary stages, each weighing 38 tons in total. A steel framework with pull-out rails was installed over the existing foundations to enable lifting and

suspension of the large stages. In addition, a steel boom was installed for depositing the components on the transport cradles and readying them for transport (Fig. 2). With deference to the very tight schedule, transport to Brauer Maschinentechnik AG in Bocholt took place at night.

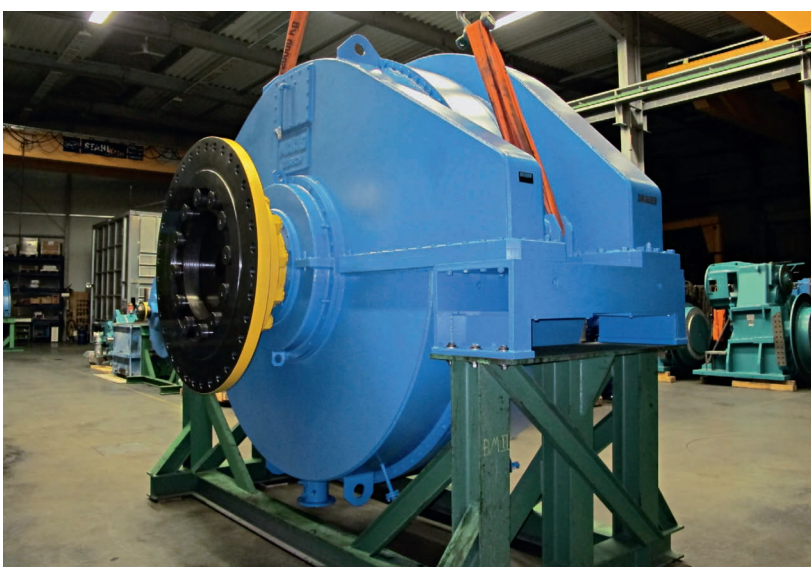
3 Big (38-ton), freshly overhauled planetary stage at Brauer Maschinentechnik AG

In order to accelerate the repair work as far as possible, the two large and two small stages were assigned to four different teams on arrival at the Bocholt facility. Hence, all components were completely disassembled and inspected in parallel operations. Damaged teeth, bearings and other component parts were either replaced or appropriately reconditioned. Casing cracks were repair-welded, and an annular-toothed ring gear with a diameter of more than 3 m was bored out to fit the existing gearbox (Fig. 3). The overhaul included a complete dimensional survey of all parts for spare-part supply purposes.

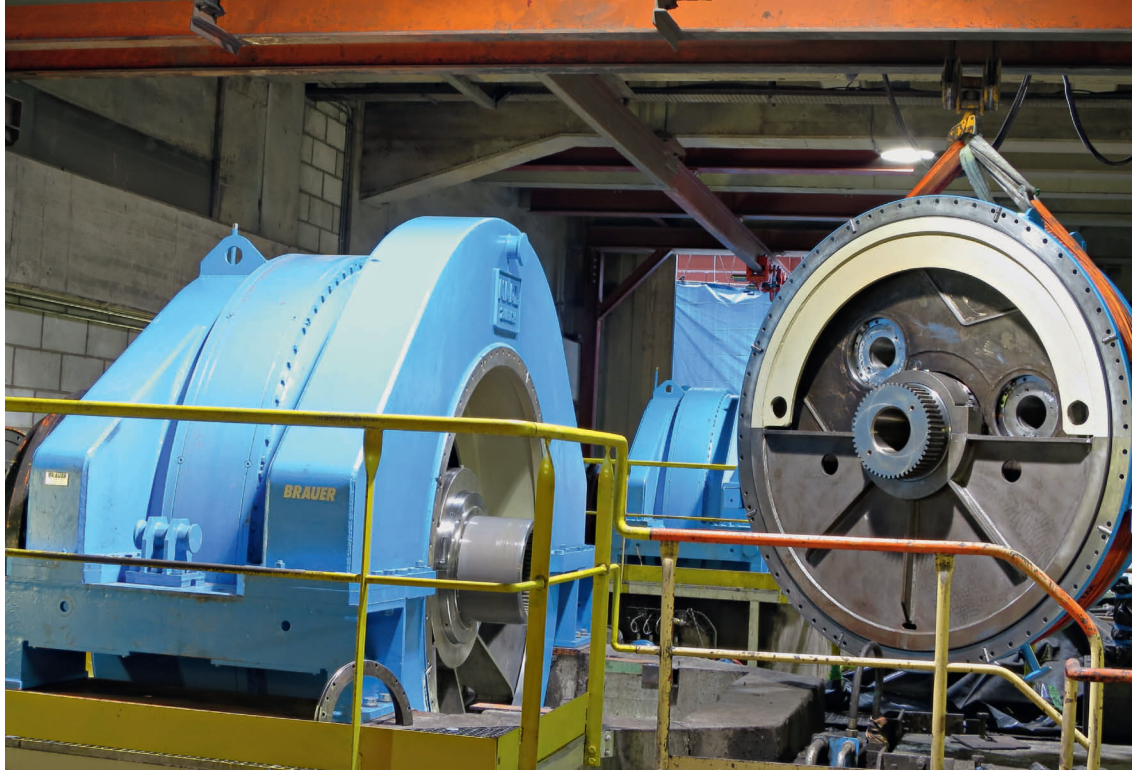
**4** Reassembly of planetary stages at production facility by Brauer Maschinentechnik AG

Nighttime transport enabled punctual return of the parts to the job site, which the local field service team had already prepared for the reassembly phase. A duty-ready truck-mounted crane was used for unloading all components and immediately reinserting them in the opposite order (Fig. 4), including final fine alignment of the gearing and motors by specialists from Brauer Maschinentechnik AG (Fig. 5). Just before the drivetrains were returned to service, their lubrication systems were cleaned and optimized.

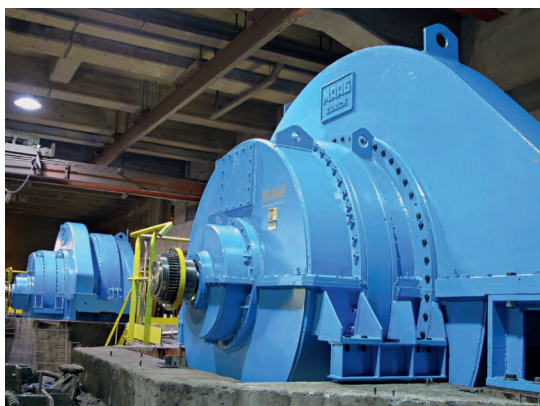
Nine month later, Brauer Maschinentechnik AG performed a video endoscopic inspection that documented, as expected, the gear units' good condition and fitness for unrestricted operation.

**5** Completely reassembled and reactivated mill gear unit
